CONNECTICUT RIVER BASIN  
MIDDLETOWN, CONNECTICUT

# HIGHLAND POND DAM CT 00147

## PHASE 1 INSPECTION REPORT NATIONAL DAM INSPECTION PROGRAM

APRIL 1981

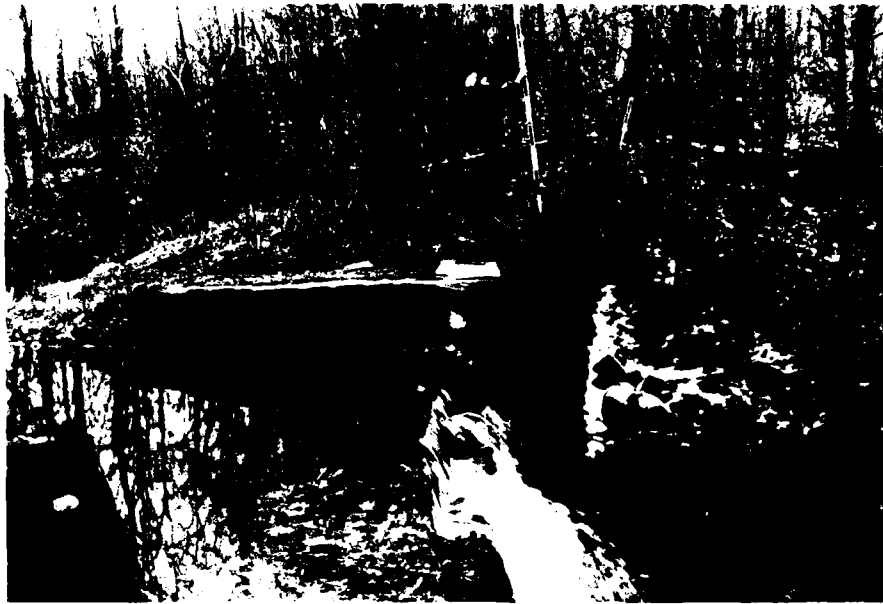
11. Crest of dam and spillway from Station 0+88 looking toward left abutment.
